**REPORT OF AN INCIDENT
INVOLVING
'PV MARY ANN OF DUNLOE'
ON
LOUGH LEANE,
KILLARNEY,
CO. KERRY
1st SEPTEMBER 2016**

**REPORT NO. MCIB/264
(No.10 OF 2017)**

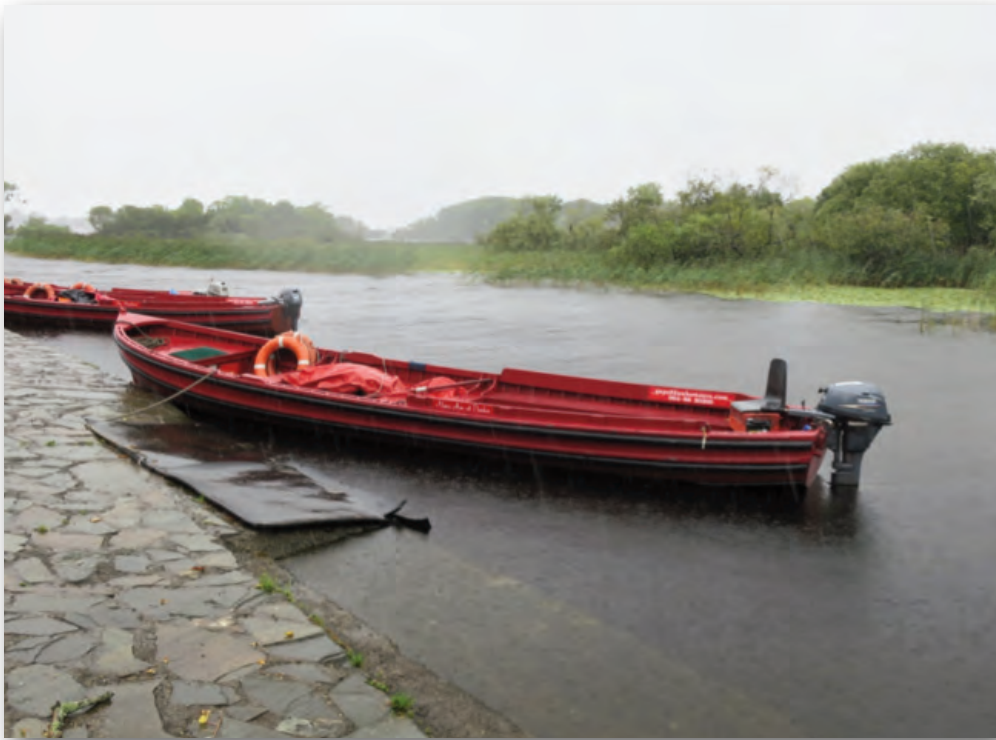
Construction: Traditional Irish clinker built, timber vessel of open configuration (see Appendix 7.1 Photograph No. 1).

Photograph No. 1: General view of vessel.

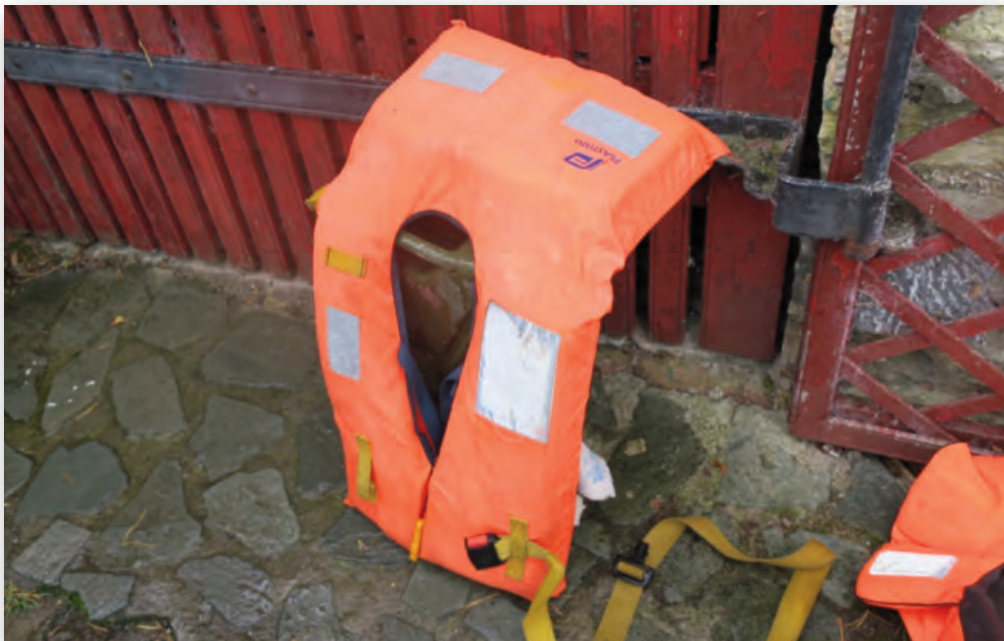
- 3.1 Prior to departure very basic safety instructions were given by the Master of the vessel. All passengers were provided with lifejackets which were donned before departure (see Appendix 7.1 Photograph No. 2).

Photograph No. 2: Typical lifejacket provided.
