**REPORT OF INVESTIGATION INTO
A FATAL INCIDENT INVOLVING A
CAPSIZED PUNT OFF
BROWNSTOWN HEAD,
TRAMORE BAY, CO. WATERFORD
ON
10th JANUARY 2013**

**REPORT No. MCIB/229
(No.11 of 2013)**

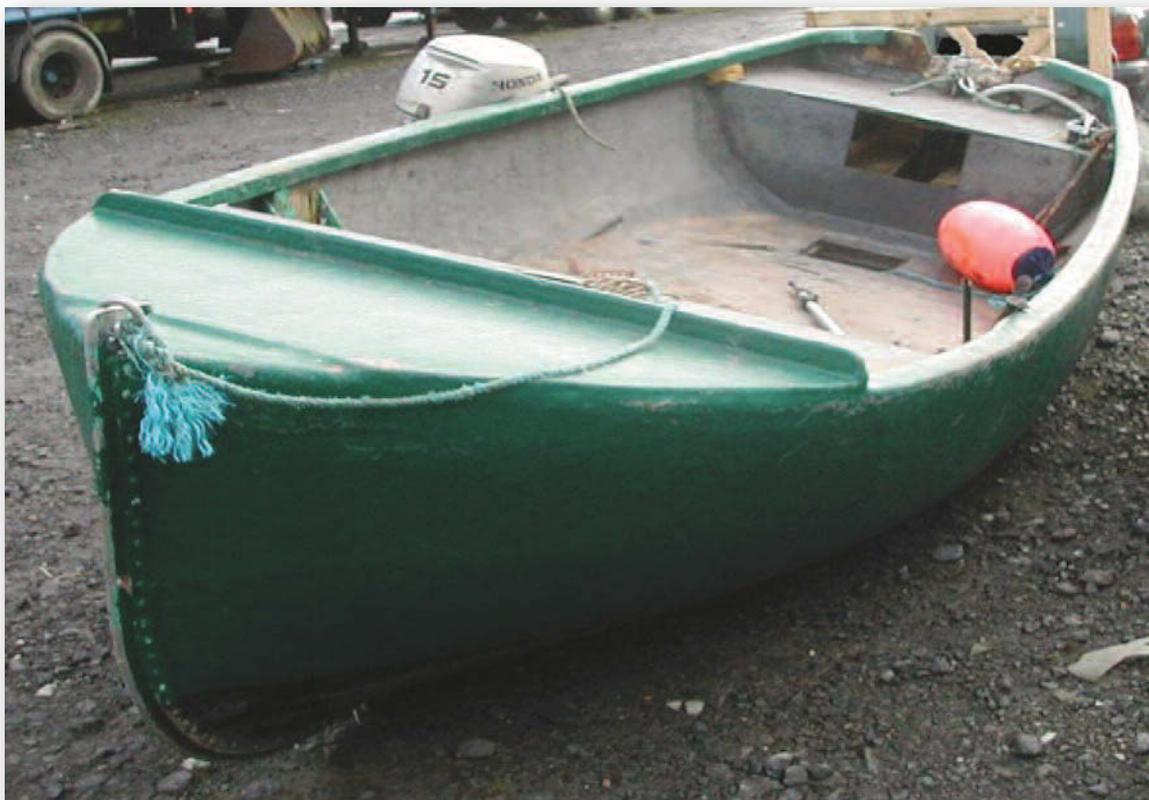
Construction:	GRP solid laminate hull with transom stern and moulded deck. Aluminium keel band, through bolted, running from stem to stern Single wood thwart forward Buoyancy chamber forward, inspection hatch and cover missing Helmsman's seat aft Transom cut away to accommodate outboard engine
Hull Colour:	Green, rough fibreglass finish without gelcoat
LOA:	4.9m (16')
Beam:	1.8m (5' 11")
Depth:	0.77m (2'6") from gunwale to keel
Engine:	Honda 4 stroke outboard engine 15 hp. Remote petrol tank stored under helmsman's seat, aft
Equipment on board:	Handheld VHF Radio Handheld GPS
Condition:	Hull solid, transom delaminating, for'd buoyancy chamber delaminating inside and inspection cover missing, helmsman's seat delaminating underneath, moulded GRP floor soft and water logged, wood thwart rotting

Mr Tate's boat ashore.

- 6.1 It is recommended that owners and/or skippers check their small boats regularly and that the inherent buoyancy of a vessel is not tampered with in any way.

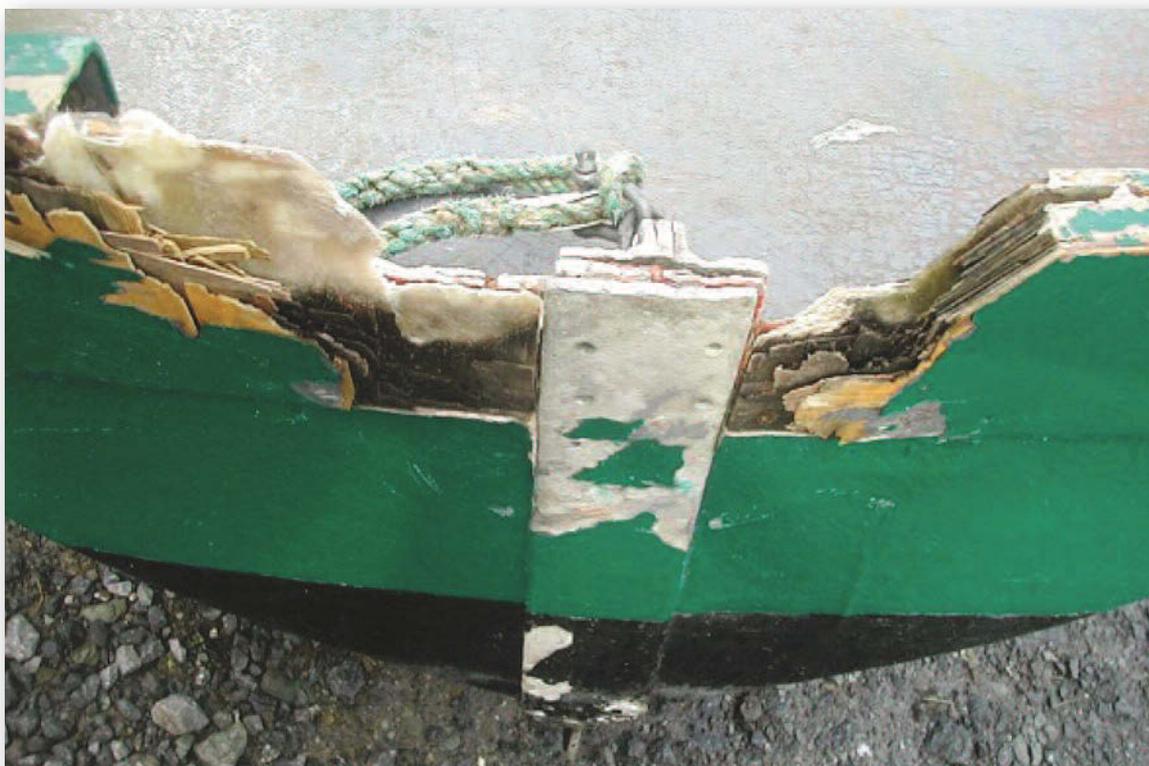
- 5.1 As an un-decked open boat, it was very vulnerable to breaking waves coming over the side and filling the boat with water. However, in order for a single large wave to totally swamp the vessel, it must have been floating very low in the water with very little freeboard. This conclusion is supported by the general condition of the vessel when inspected following the incident which showed it to be quite waterlogged in places and probably much heavier than as originally built. The aft buoyancy chamber had also been cut open providing storage for the fuel tank, further reducing the inherent buoyancy of the boat.

The delaminating transom of the boat.

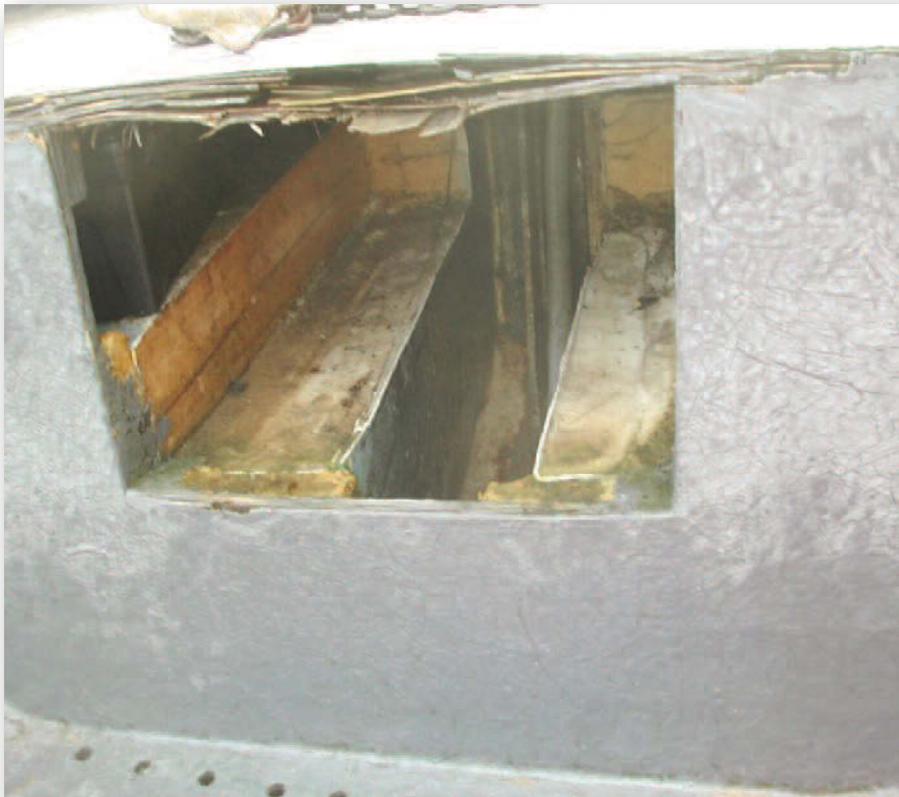
The cut away under the helmsman's seat showing delamination.

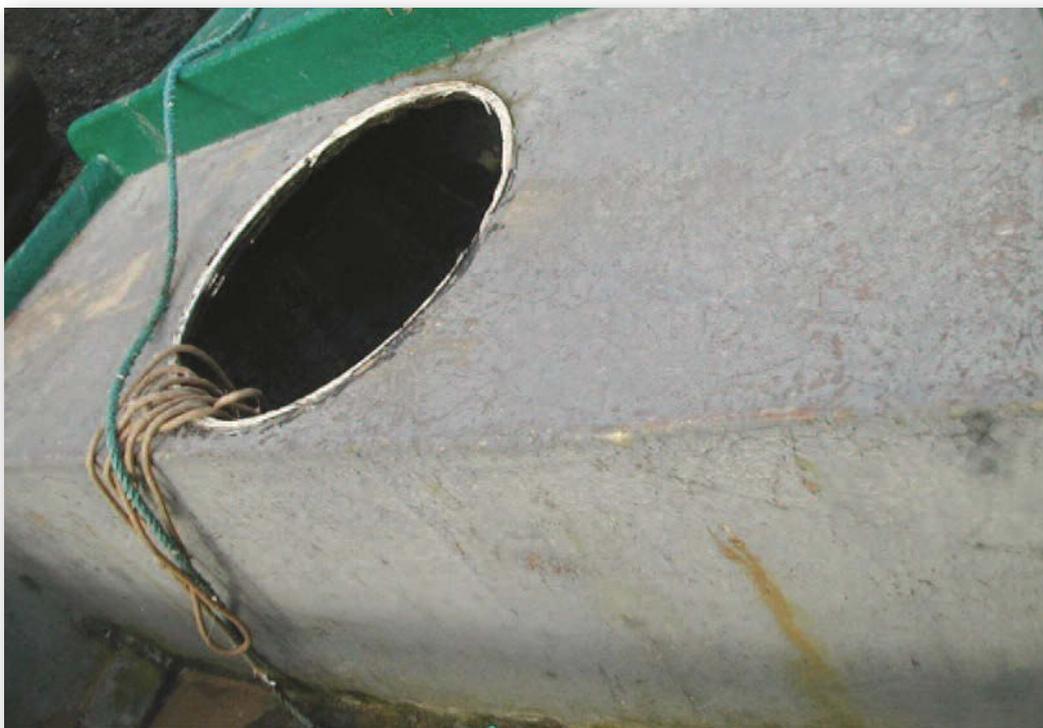
The for'd buoyancy chamber showing the missing inspection hatch and lid.

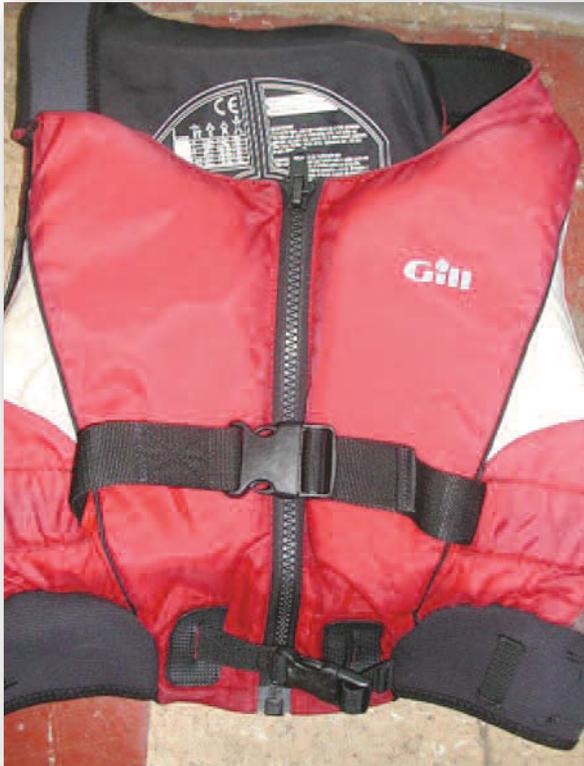
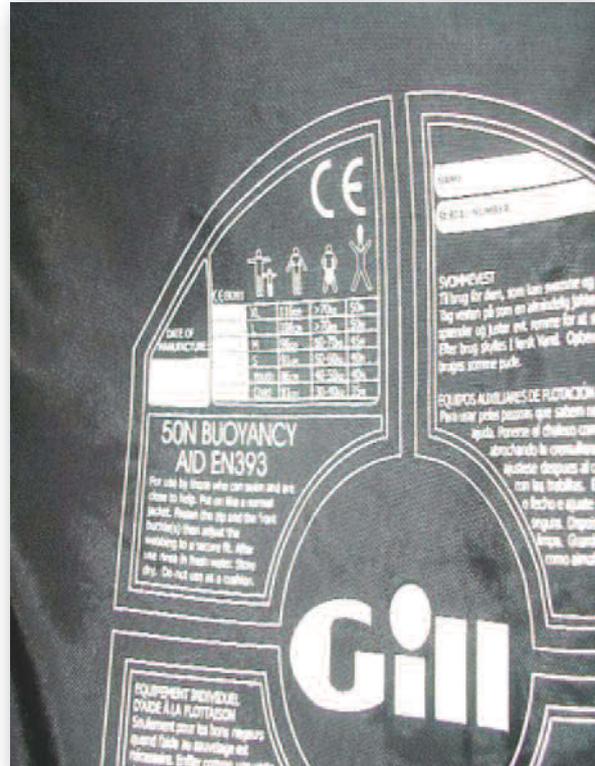
Appendix 7.2 Mr Flynn's buoyancy aid.

- 4.6 Whilst both men were wearing personal flotation devices of suitable size and buoyancy for their weight, neither was equipped with a collar to keep the wearer on his back and his head above the water or crotch / thigh straps to prevent the jacket from riding up over the wearer's head. Nor was either buoyancy aid equipped with a light or a whistle.

- 5.4 If the personal flotation device worn by Mr Flynn were fitted with a collar, it would have likely helped to keep his head above water and could have contributed to his possible survival. Further, had it been equipped with a light and a whistle, it would have made Mr Tate aware of his whereabouts.

- 6.2 It is recommended that personal floatation devices must be worn by persons in open boats less than 7m such as detailed in S.I. 921 of 2005, as amended.

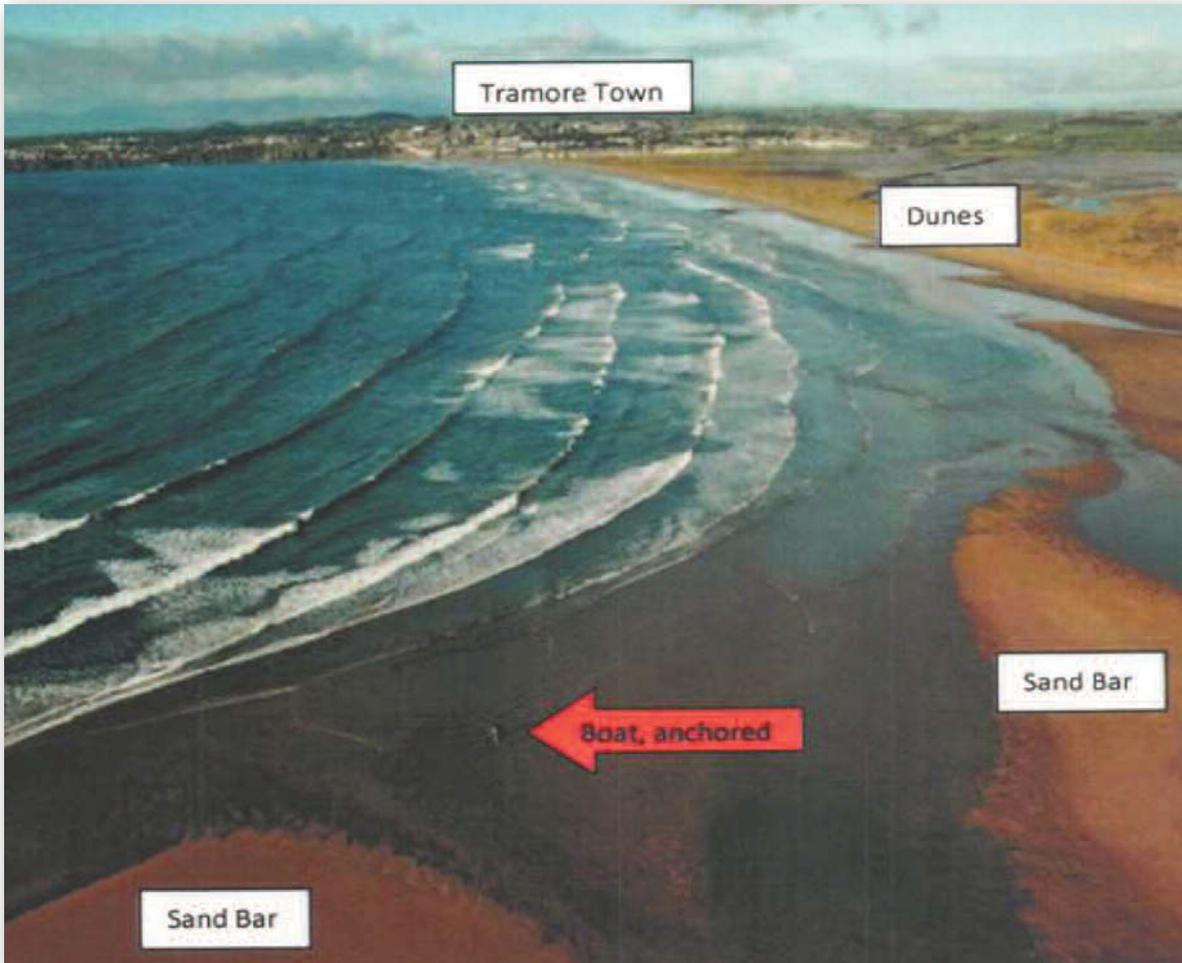
Appendix 7.3 Aerial view of incident location approximately 7 hours after incident.

Boat upright anchored on sand bar with tide flooding approximately 7 hours after incident.
