**Iascach Intíre Éireann
Inland Fisheries Ireland**

River Shannon Eel Kill Investigation

9th & 10th December 2021

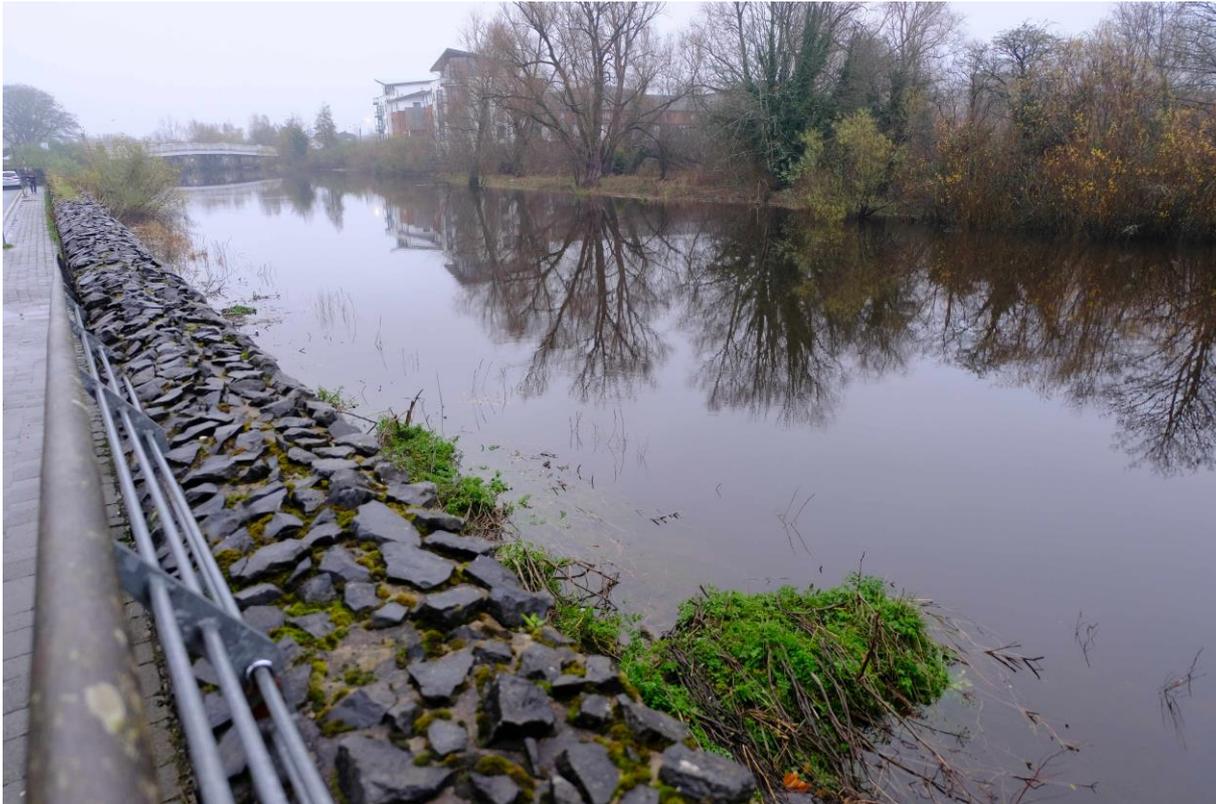
Figure 2 The Abbey River at the Absolute Hotel, Limerick City, Thursday December 9th.

Due to tide and weather constraints, IFI were unable to launch a boat and instead investigations took place on foot. All accessible riverbank from Ardnacrusha to the Abbey River and including Corbally was walked. This took place from first light for much of the day. No eels were located during these searches.

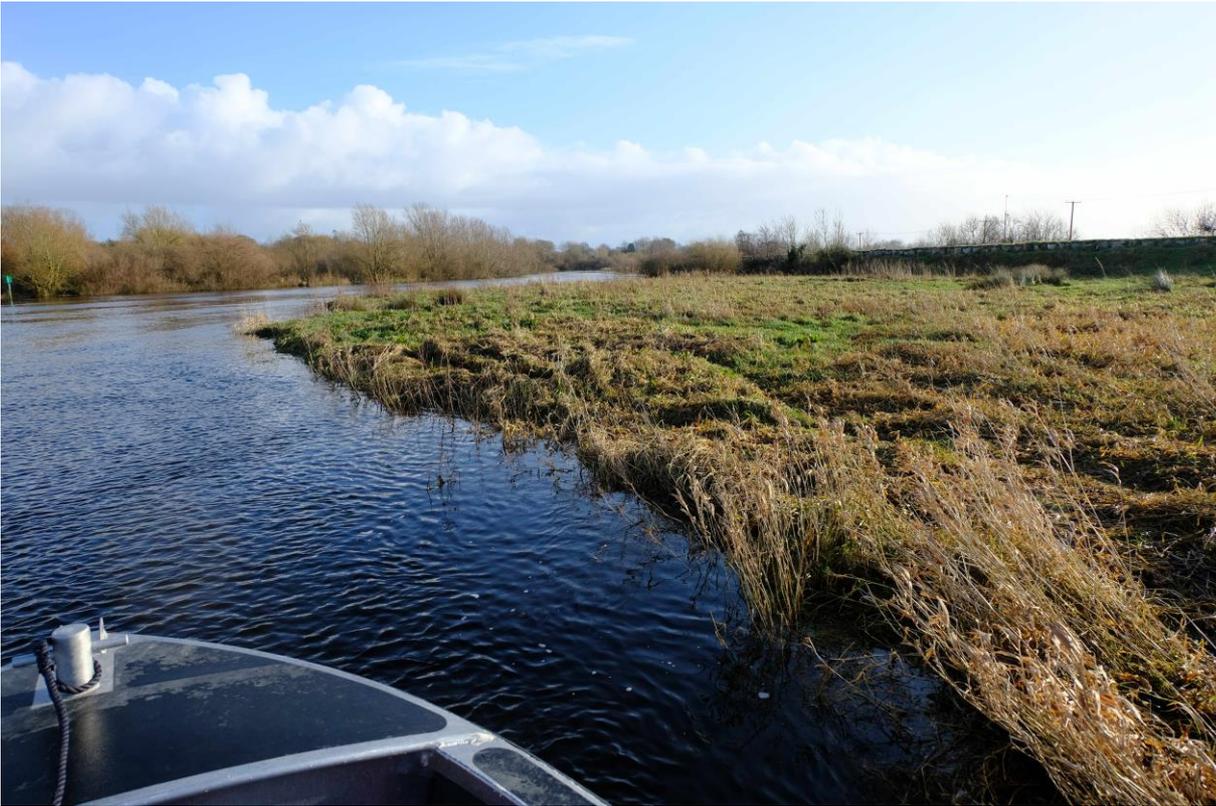
Figure 3 Shoreline search at St. Mary's Park

IFI launched a patrol boat to undertake a more comprehensive survey of the river from Ardnacusha to the Marina in Limerick City. The shoreline of the Abbey River, the main channel of the River Shannon and the tailrace at Ardnacrusha were extensively searched. Particular attention was paid to any areas where eels might have become entangled were searched. Despite these extensive searches staff managed to recover only one eel from the Abbey River (see photo on cover page). While this eel had some damage to the head it is impossible to say whether this was due to turbine strike to predator or other post-mortem damage.

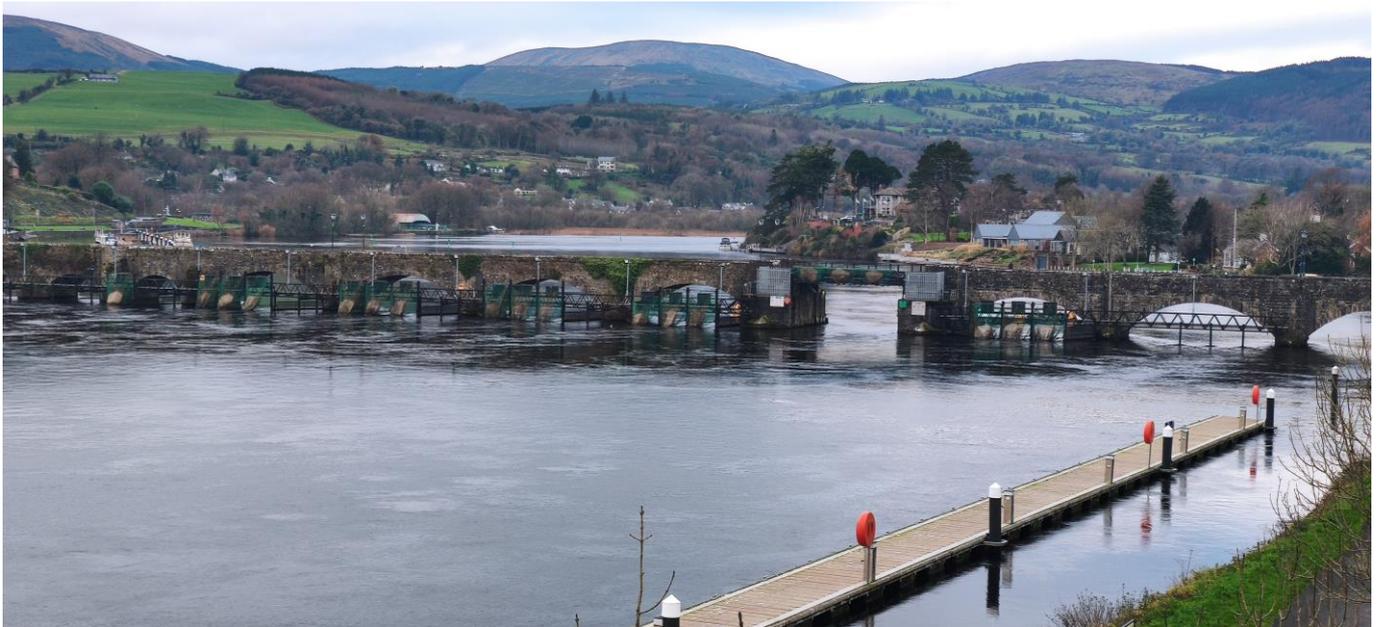
Figure 4 Eel nets set at Killaloe Bridge in the up (not fishing) position

Catches for the following week were significantly higher than during Storm Barra with 328kg taken on the night of the 13th of December. This data would suggest that a very large run of eels did not take place on the night of December 7th/8th as a larger catch than reported would have been expected in the nets. The net catches are only indicative of the run however as they do not cover the whole channel, but they do cover the main flood eyes of the bridge.
